ATK Armament Systems
Energetic Systems
Radford Army Ammunition Plant
Route 114, P.O. Box 1
Radford, VA 24143-0100

Subject: Air Compliance Reports

TITLE V SEMI-ANNUAL MONITORING REPORTING FORM

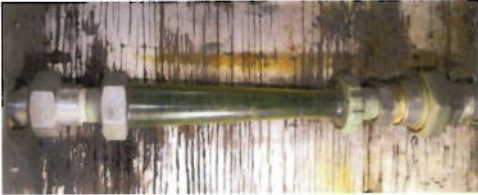
Permit Condition No. & DESCRIPTION OF REQUIREMENT	DESCRIPTION OF DEVIATION (including date)	REASON FOR DEVIATION & CORRECTIVE ACTION TAKEN
<p>VII.B.4 The piccolo scrubber shall be equipped with a device to continuously measure the scrubber liquid flow rate. The monitoring device shall be installed, maintained, calibrated and operated in accordance with approved procedures which shall include, as a minimum, the manufacturer's written requirements or recommendations. The monitoring device shall be provided with adequate access for inspection and shall be in operation when the scrubber is operating.</p>	<p>Algae buildup on the rotameters used to measure the piccolo scrubber liquid flow rate prevented personnel from easily determining the rate on the dates during this reporting period. The piccolo scrubber was in service on 1/1-1/4, 1/23-1/24, 1/30-2/4, 2/11-2/12, 2/13, 3/11-3/12, and 3/20 before April 2012.</p> <p>The observed condition of the rotameter indicates that it was not maintained with approved procedures as required by this condition even though the rotameter was in operation when the scrubber was in service.</p>	<p>After this deviation was identified in January 2012 during preparation of the semi-annual report, initial steps were initiated to clean the rotameter so that it would be able to indicate flow when the piccolo scrubber was in service during 2012. Cleaning improved the condition of the rotameter so flow could be observed but the algae grew back. The rotameter was replaced with a flow meter in April 2012 as shown below.</p> <div data-bbox="630 623 1105 816">

<p>Rotameter with algae growth</p> </div> <div data-bbox="630 403 1105 598">

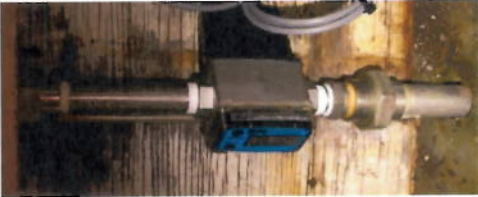
<p>Flow meter installed April 2012</p> </div>

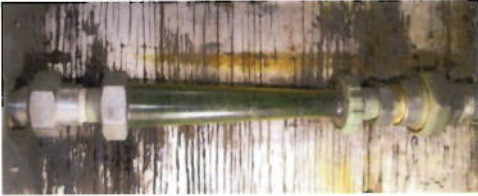
Permit Condition No. & DESCRIPTION OF REQUIREMENT	DESCRIPTION OF DEVIATION (including date)	REASON FOR DEVIATION & CORRECTIVE ACTION TAKEN
<p>VII.B.4 The piccolo scrubber shall be equipped with a device to continuously measure the scrubber liquid flow rate. The monitoring device shall be installed, maintained, calibrated and operated in accordance with approved procedures which shall include, as a minimum, the manufacturer's written requirements or recommendations. The monitoring device shall be provided with adequate access for inspection and shall be in operation when the scrubber is operating.</p>	<p>Algae buildup on the rotameters used to measure the piccolo scrubber liquid flow rate prevented personnel from easily determining the rate on the dates during this reporting period. The piccolo scrubber was in service on 1/1-1/4, 1/23-1/24, 1/30-2/4, 2/11-2/12, 2/13, 3/11-3/12, and 3/20 before April 2012.</p> <p>The observed condition of the rotameter indicates that it was not maintained with approved procedures as required by this condition even though the rotameter was in operation when the scrubber was in service.</p>	<p>After this deviation was identified in January 2012 during preparation of the semi-annual report, initial steps were initiated to clean the rotameter so that it would be able to indicate flow when the piccolo scrubber was in service during 2012. Cleaning improved the condition of the rotameter so flow could be observed but the algae grew back. The rotameter was replaced with a flow meter in April 2012 as shown below.</p> <div data-bbox="630 623 1105 816">

<p>Rotameter with algae growth</p> </div> <div data-bbox="630 403 1105 598">

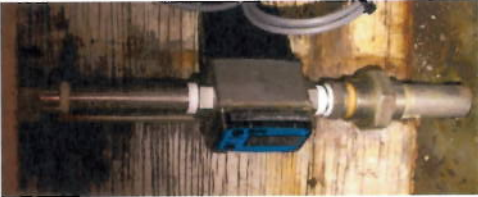
<p>Flow meter installed April 2012</p> </div>
